# Manhole Inspection Summary

Manhole # S04YY1010MH

Insp Date: **7/5/06 10:41 AM**

**Location** Address: **3701 WILLIAMSON AVE**

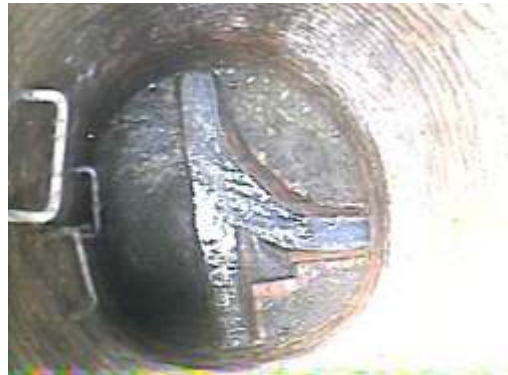
Top View

Corbel infiltration. Evidence of surcharge - Bench debris.

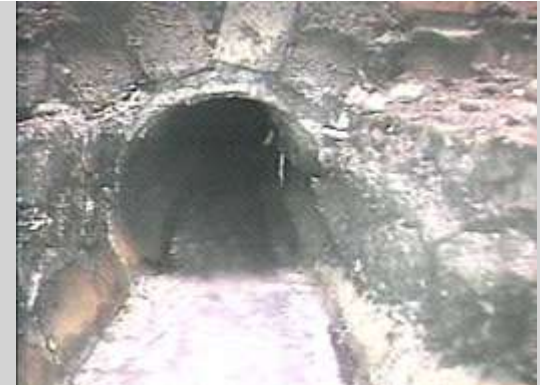
### 8 in. Circular Gravity Sewer Pipe Out @ 12 O'Clock

Comments **The O12 pipe picture shows heavy grease deposits in the Channel.**

Barrel deterioration and infiltration. Grease deposits.

Deposits: ☐ None ☐ Mud ☐ Sludge ☐ Debris ☒ **Grease**

Silt Depth: **0** (in.) Deposits Extent: **Medium**

Infiltration: **Evidence** Pipe Seal Cond: **Unknown**

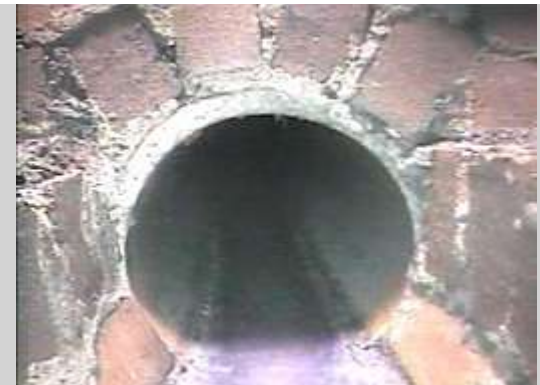
### 8 in. Circular Gravity Sewer Pipe In @ 3 O'Clock

Deposits: ☐ None ☐ Mud ☐ Sludge ☐ Debris ☒ **Grease**

Silt Depth: **0** (in.) Deposits Extent: **Light**

Infiltration: **Evidence** Pipe Seal Cond: **Unknown**

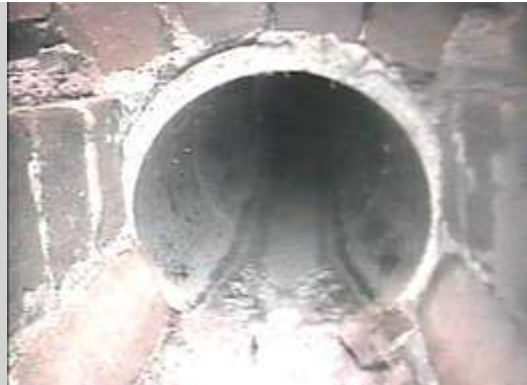
Pipe In @ 6 O'Clock

Deposits: ☐ None ☐ Mud ☐ Sludge ☐ Debris ☒ **Grease**

Silt Depth: **0** (in.) Deposits Extent: **Light**

Infiltration: **Evidence**
